Property Inspection Report

Report Number: 20220002 Sample

1 Main St
Greensboro, North Carolina 27401

Date of Inspection: Wednesday, December 14, 2022

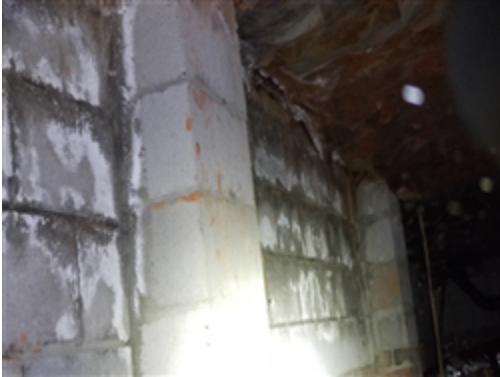
(A1 - 1.1) All Accessible Areas

Efflorescence (salt stains) was noted on the foundation walls. The stains indicate that the foundation was been cyclically wet and dry. Water penetration into the foundation area can result in structural damage and undesirable environmental conditions. Water in the foundation area indicates an absent or damaged waterproofing and foundation drain systems. Repairs are needed to prevent water penetration. A licensed general contractor with experience in foundation drainage and water proofing that should be consulted for a complete evaluation to determine the source of the moisture and to make necessary repairs.

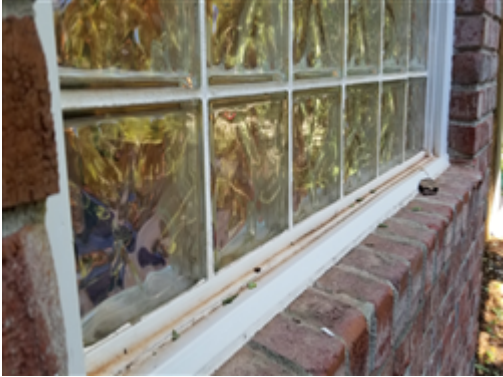
(B1 - 1.1) Right Side

The sill on the glass block window is sloping towards the house and will pool water. It should slope away from the house to shed water. Pooling of water can cause wood rot and deterioration. A licensed general contractor should be contacted to review and repair.

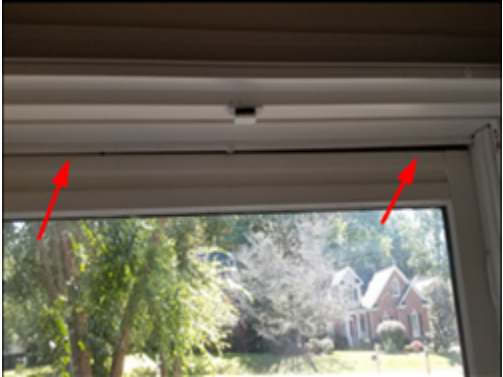
(B2 - 1.1) All Windows

More than half the windows in the house were difficult to operate or inoperable. This included windows in the master bedroom, living room, kitchen and 3 bedrooms.

The attached picture shows the window in the Master Closet. The top window is jammed and the arrows point to the inconsistent gap at the top indicating the window is crooked in the frame.

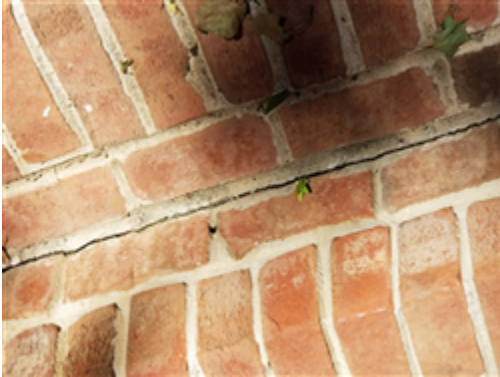
(B3 - 1.1) Front

The masonry steps are in need of repair. The steps have rotated or moved away from the foundation. The crack should be caulked to prevent water penetration and further movement. A licensed general contractor should be consulted if the crack size increases.

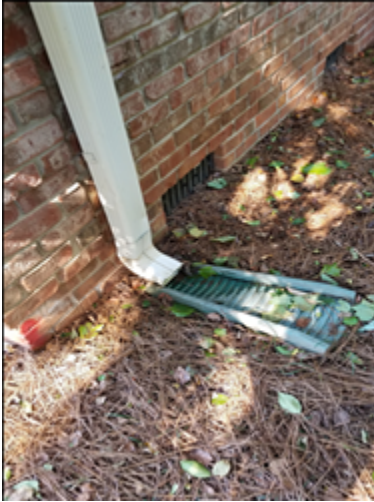
(C2 - 1.1) Right Side

The gutter extension on the right side of the house was not sloped to drain away from the foundation. Direct drainage to the foundation and cladding from the gutter system can result in water penetration into the foundation area and foundation deterioration. A licensed general contractor should be consulted for a complete evaluation of the gutter system to reduce overflow and to make necessary repairs.

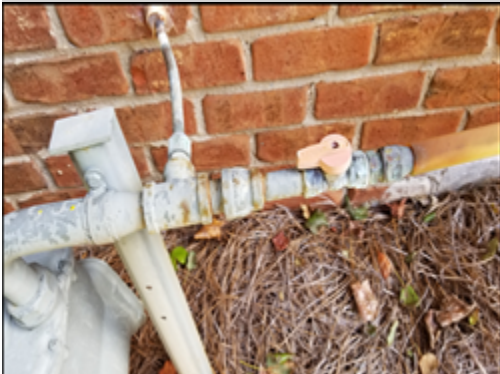
(F3 - 1.1) Crawl Space

The gas line was noted to be corroded. Corrosion on a gas line is a serious concern that could result in leaks and or hazardous conditions. A plumbing or HVAC contractor should be consulted for a complete evaluation and repair of the gas line installation.

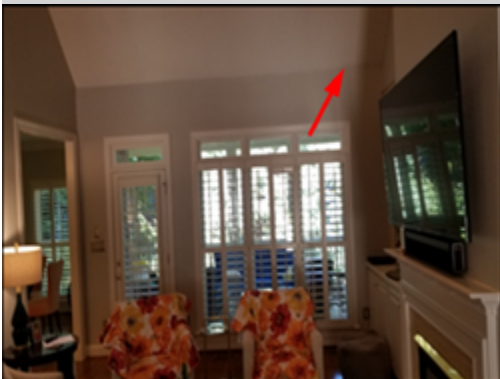
(H1 - 1.1) Living Room

Stains on the ceilings indicate a history of a leak. At the time of the inspection it was not possible to determine if the condition was due to an active or past occurrence. Further investigation by a repair specialist and owner disclosure is recommended. Refer to the XXX section of the report.
